Appendix B - Trouble Shooting Guide for NatSol Twin Vault Toilets

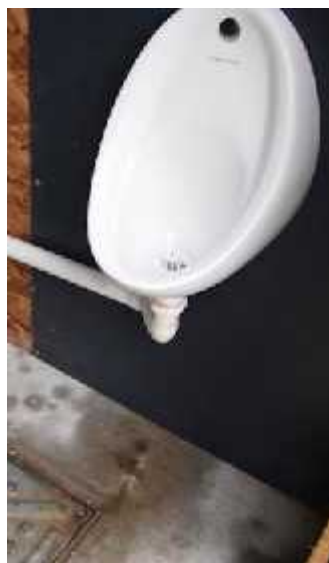
The usual culprit is urine on the floor. This could be due to a leaking waste connection on the urinal and this can be checked by pouring water into the bowl. However, it is more likely to be due to urine splashes. If the toilet is used a lot by small boys then it may be essential to provide a box to stand on or to install an additional urinal to the left of the standard one at a lower height. NatSol can advise on this and supply components. Otherwise the solution is regular cleaning.

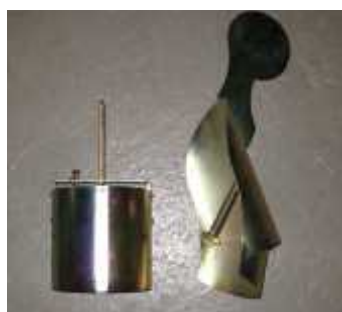
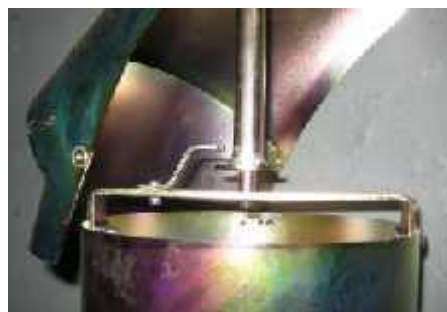
Normally air is drawn down the pedestal and up the vent pipe so that no smells enter the building. If the vent pipe is blocked (cobwebs, bird's nest etc.) or the cowl is not free to align with the wind direction then the ventilation won't work. If you remove the upper part of the cowl it is possible to see down the vent pipe. Move the retaining catch aside to remove the upper part. **Be careful of the spike sticking up from the lower part.** If the toilet pedestal is in the RH position, lift the lid to let some light into the chamber. If the pedestal is in the LH position you may need to remove the rear RH hatch. If the cowl is stiff then add some fresh general purpose grease. Re-position the retaining catch afterwards.
